Kriegsmarine U-Boat Colours & Markings

by Dougie Martindale

The following article attempts to provide a general guide to the colours used upon the German U-boats of the Second World War. It was published complete with 51 black and white photographs in the September 2004 (#58), December 2004 (#59) and March 2005 (#60) issues of the SubCommittee Report. This is a quarterly magazine published by the SubCommittee, a non-profit organisation who share an interest in submarines, primarily the building of radio-controlled submarine models. Their website can be found at <http://www.subcommittee.com/>

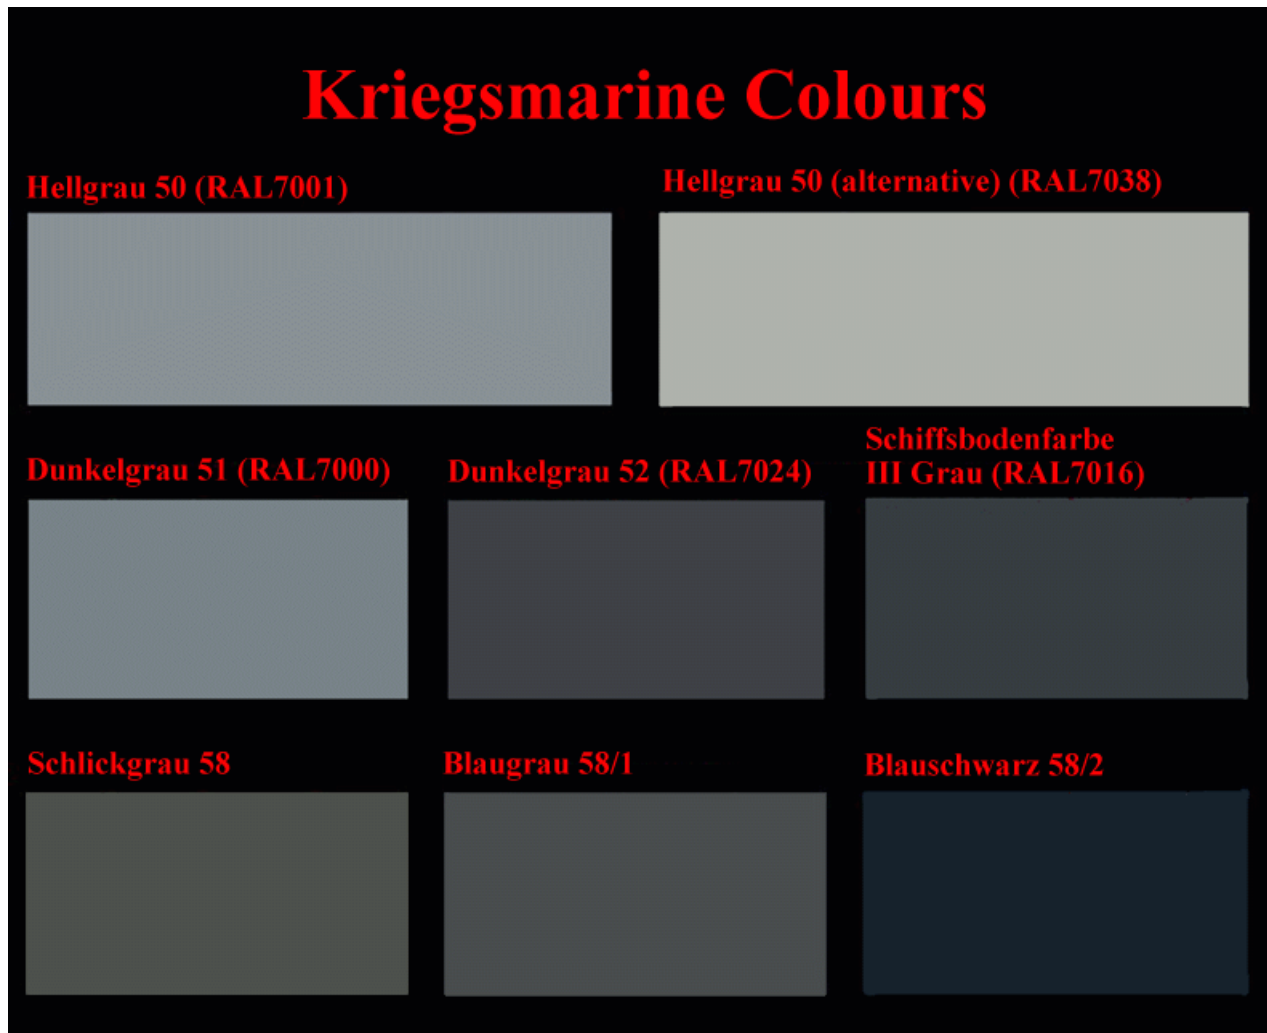
Above: The colours in the above guide are based upon the RGB (red, green, blue) values of the RAL colours. These values were obtained from a diskette purchased from *Multicolor UK Ltd.*, RAL's sales partner in the UK. For the Kriegsmarine colours which had no RAL code associated with them (the bottom three), the colours were matched as best as possible from the two-part set of Kriegsmarine paint chip cards produced by *Snyder & Short Enterprises*. Note that variances will occur due to monitor settings.

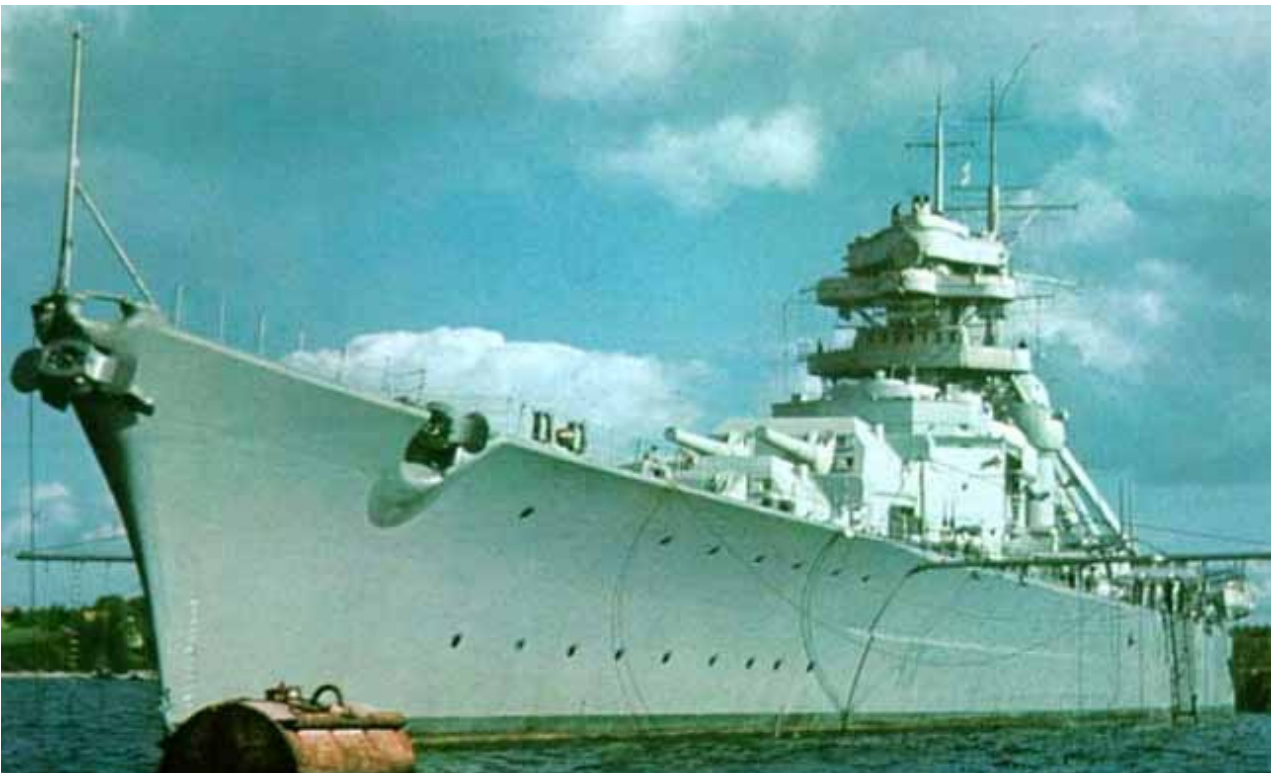
Above: This 1940 colour photo of the mighty Kriegsmarine battleship *Bismarck* is useful to us because the paint regulations specify the paint colours we see before us. The hull is *Dunkelgrau 51* and the superstructure – looking very light under the shining sun – is *Hellgrau 50*. The bootline just above the water is not black but the dark grey *Wasserlinienfarbe W.L. III Grau*. This paint has the same number, 23b, as the paint used

on the lower hulls of U-boats, *Schiffsbodenfarbe III Grau*. They are in fact the same paint, with the same colour (RAL7016), merely with different names.

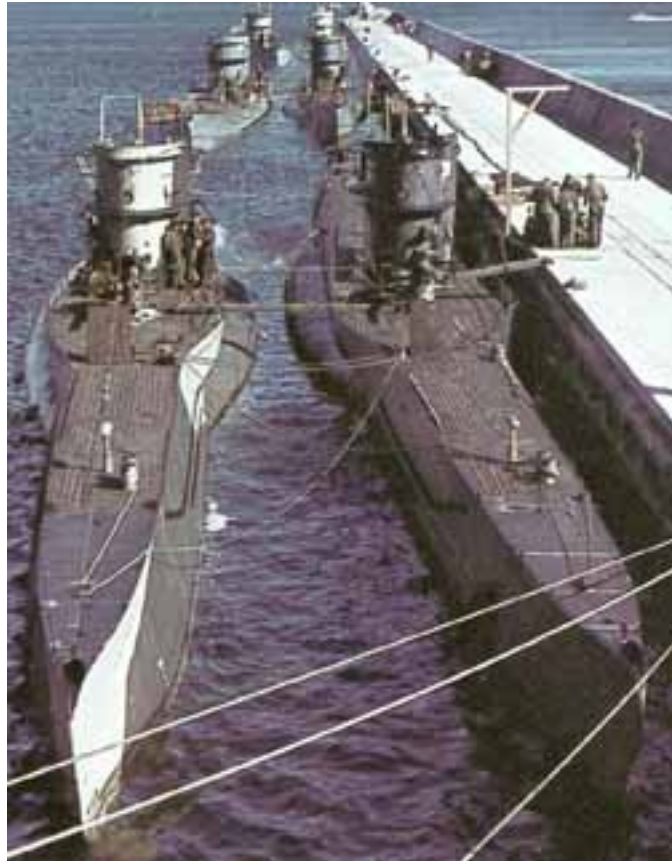
Above: Comparisons between the *Bismarck* photo and this 1942 photo, also taken in strong sunlight, show similarities between paint colours. The medium blue-grey colour on the boat on the front right (U 335), and on the VII and IX (U 163) in the second row, is similar to the *Dunkelgrau 51* hull of the *Bismarck*. The light grey on the camouflaged U 253 on the front left, and the two U-boats in the third row, appear similar to the *Hellgrau 50* on the *Bismarck*'s superstructure. Note also the wooden deck colour, covered later in the article.

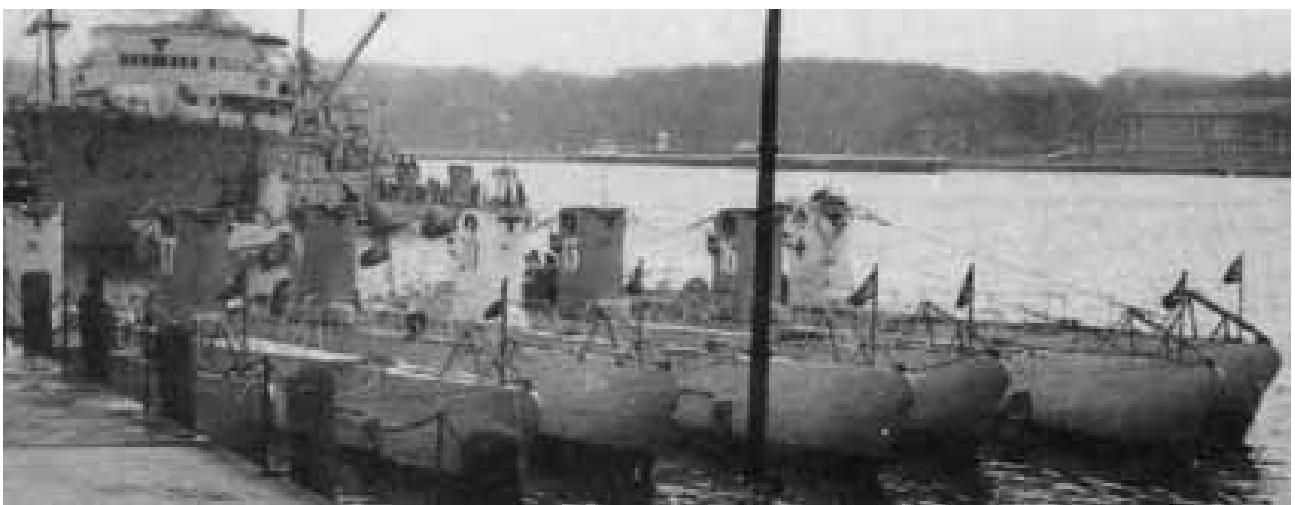
Above: Photos such as this one, in which the colour of the U-boats can be compared to the *Dunkelgrau 51* hull and *Hellgrau 50* superstructure of the tender, are valuable tools

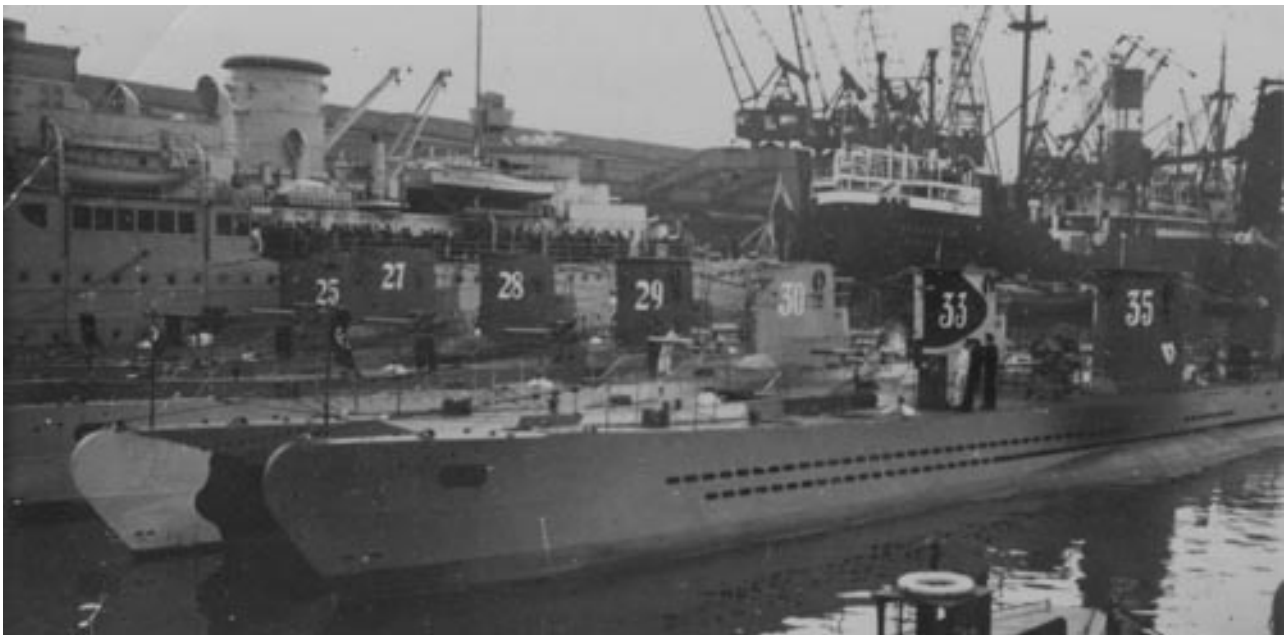
Above: The *Saltzwedel* Flotilla in Bremen during 1937. Once again different schemes are evident, and again the presence of the tender helps us with paint colours. Most of the boats are darker than the tender's *Dunkelgrau 51* hull; they may be in *Dunkelgrau 52*. U 33 is painted in alternative Spanish Civil War markings.

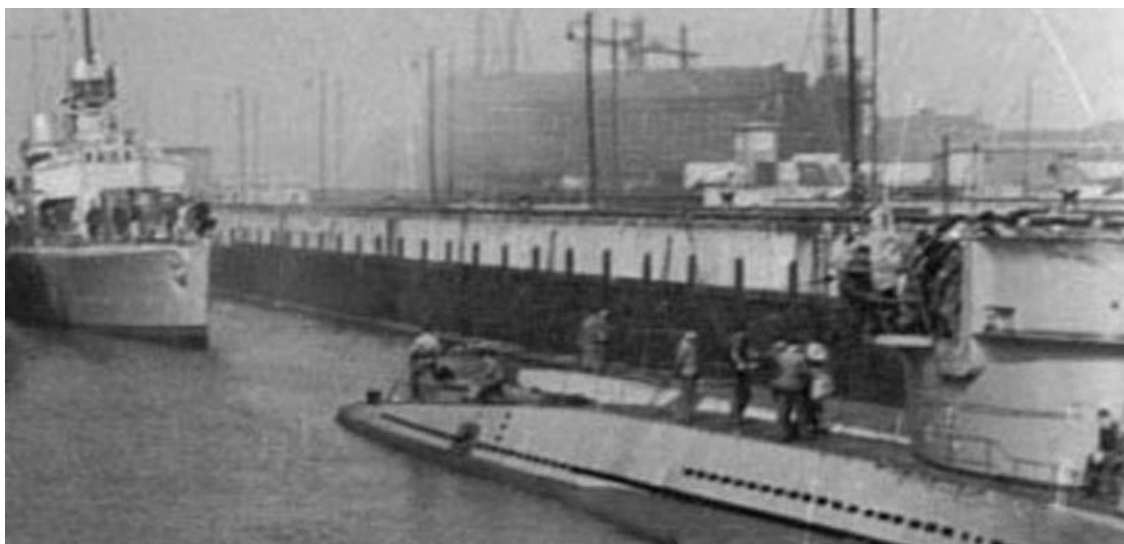
Above: If we could only see the right half of this photo, may we have assumed the upper colour of the original VII was the light grey *Hellgrau 50*? The ship in the left hand side provides us with a vital clue. Once again the ship has a *Hellgrau 50* superstructure and *Dunkelgrau 50*. The U-boat was therefore probably in *Dunkelgrau 51*.

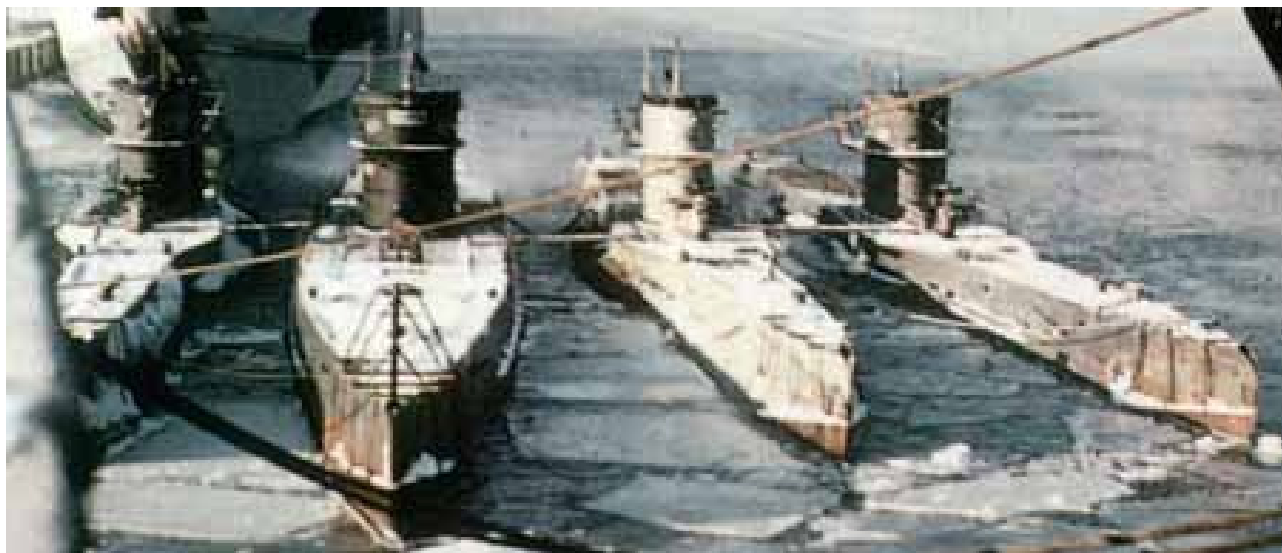
Above: The U-boats seen here in Gotenhafen have rusty protective caps over their bows to prevent damage from ice. The decks are covered under a layer of snow. The IX second from the left, U 37, looks particularly dark.

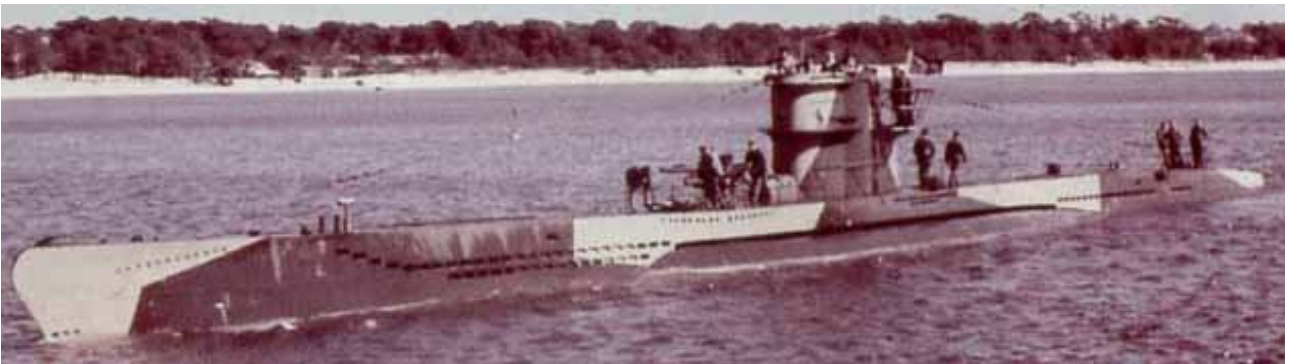
Above: U 253 in 1942, with a distinctive camouflage scheme. The RAL7016 used upon the lower hull was extended over some areas of the upper hull and conning tower of U 253. The light grey looks like *Hellgrau 50*.

U 253	April/May 1942	3 irregular-shaped areas with sharp edges in RAL7016
U 453	1943 or 1944	Inverted V on tower with patches on upper hull
U 556	30 th May 1941	5 slightly wavy, feather-edged stripes of variable width on starboard side; unknown number on port side
U 561	5 th Sept. 1942	Wide dark band on tower
U 596	1942 or 1943	Mediterranean jagged splotches over tower and upper hull
U 711	30 th July 1944	One thin, very dark wavy line on tower, plus two similar lines on upper hull, over white or light grey

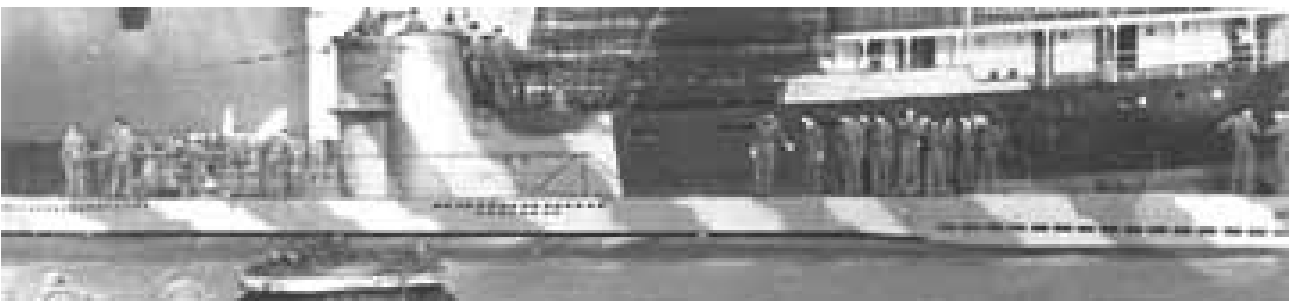
Above: Due to the aesthetic camouflage scheme employed upon U 201 (seen here in Brest in 1941), the boat is a popular choice for modelmakers. Darker grey wavy stripes were sprayed on over a lighter grey on a few Atlantic-based U-boats. The number of stripes varied from boat to boat. Note that the darker grey was still lighter than the dark grey anti-fouling *Schiffsbodenfarbe III Grau* on the lower hull.

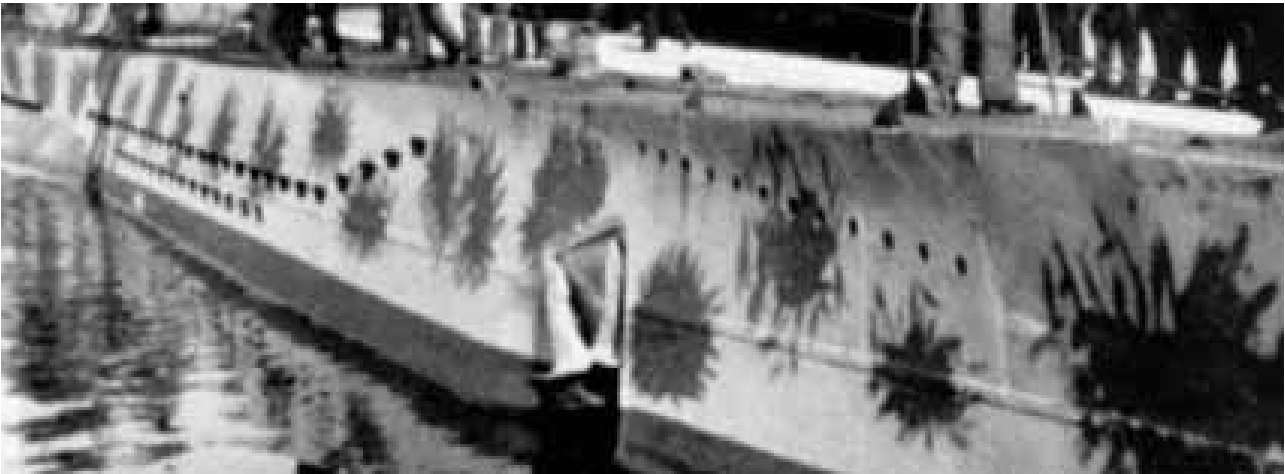
Above: An example of the dark splotches with jagged edges that were added to the upper hull and the conning towers of a number of boats serving in the Mediterranean.

In the Mediterranean, the theatre where camouflage was most commonly found, a pattern of dark grey jagged splotches applied at regular intervals over the upper hull and conning tower was commonly used. Sometimes, as on U 453, there were patches with hard edges rather than jagged splotches. As the waters of the Mediterranean are much clearer than the Atlantic, U-boats could be seen from the air at a greater depth. A U-boat at periscope depth could be clearly seen from the air in daylight, so the pattern of dark splotches or patches was intended to break up the U-boat's shape sufficiently to prevent detection from the air.

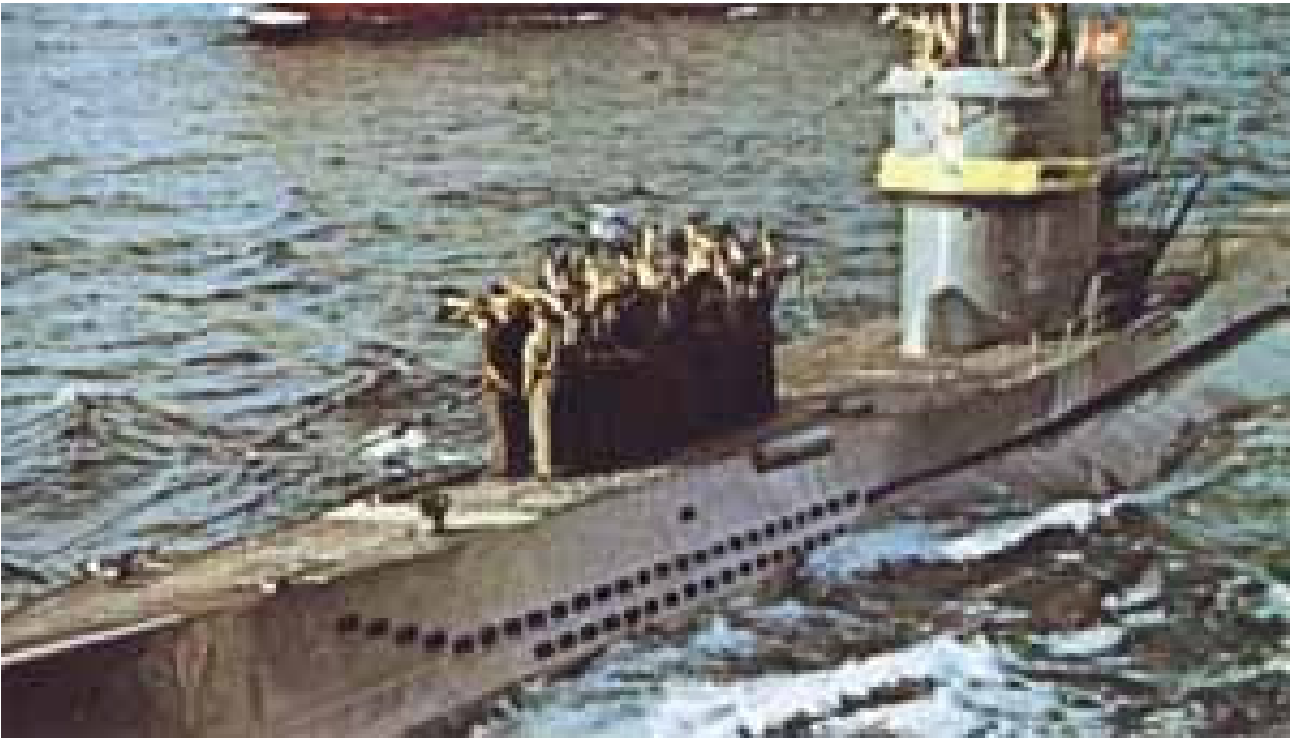
Above: The yellow band above U 749's spray defector and the other band on the foredeck, just behind the capstan, indicate that the boat was involved in training. Not visible in this image is the other yellow band that would have been present on the aft deck.

U-boats that were involved in training had yellow (*Deckfarbe Gelb*, RAL1003) identification bands around the conning tower (just above the spray deflector) and across the deck. In some cases red (*Deckfarbe Kaiserrot I* (RAL 3010) or *Deckfarbe Rot* (RAL 3011)) was used rather than yellow. U-boats that belonged to training flotillas each had an individual marking which would identify them from another boat.

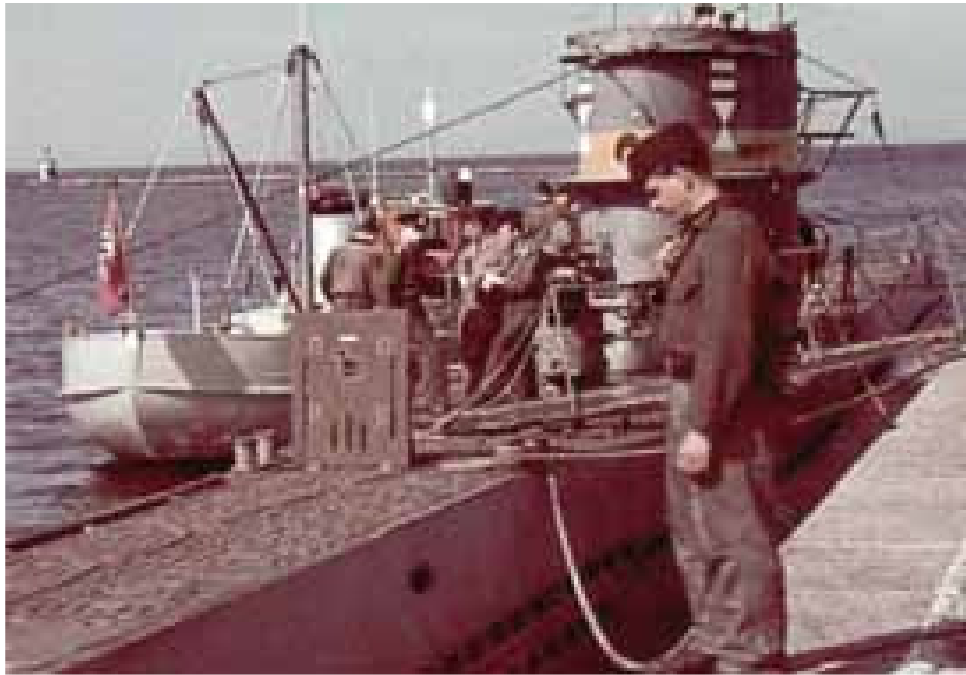
Above: U 302 in the Baltic during the late summer of 1942. The yellow band indicates that the boat was assigned to training at this time. The white triangles and lines on the tower are UAK tactical markings. Note that the grey above the yellow band is darker than the grey on the lower half of the tower and hull sides.

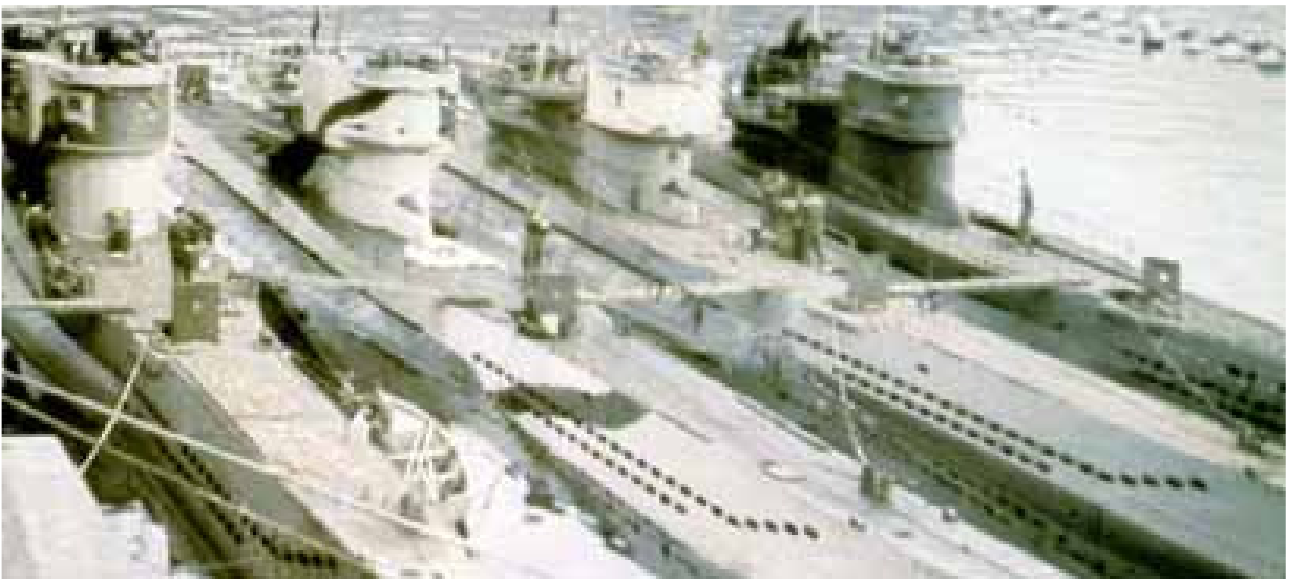
Above: This photos shows, from left to right, U 362, U 711, U 278 and U 997, on the 30th July 1944. On the two middle boats, the upper half of the fairing in front of the conning tower (which housed the magnetic compass) is black or dark grey.

Horizontal surfaces – The horizontal surfaces such as the spray deflector and the upper half of the fairing in front of the conning tower (which housed the magnetic compass) were sometimes painted black or dark grey (regulations state black) for camouflage purposes. On rarer occasions the wind deflector was also painted black or dark grey. The dark grey, on occasions, may have been *Dunkelgrau 53* (RAL7016), as it was common practice to paint the horizontal metal surfaces of Kriegsmarine warships with this paint (see Lfd. Nr. 31 and 31a in the July 1944 painting regulations). It could also be possible that the anti-fouling paint *Schiffsbodenfarbe III Grau* (RAL7016) was sometimes used.

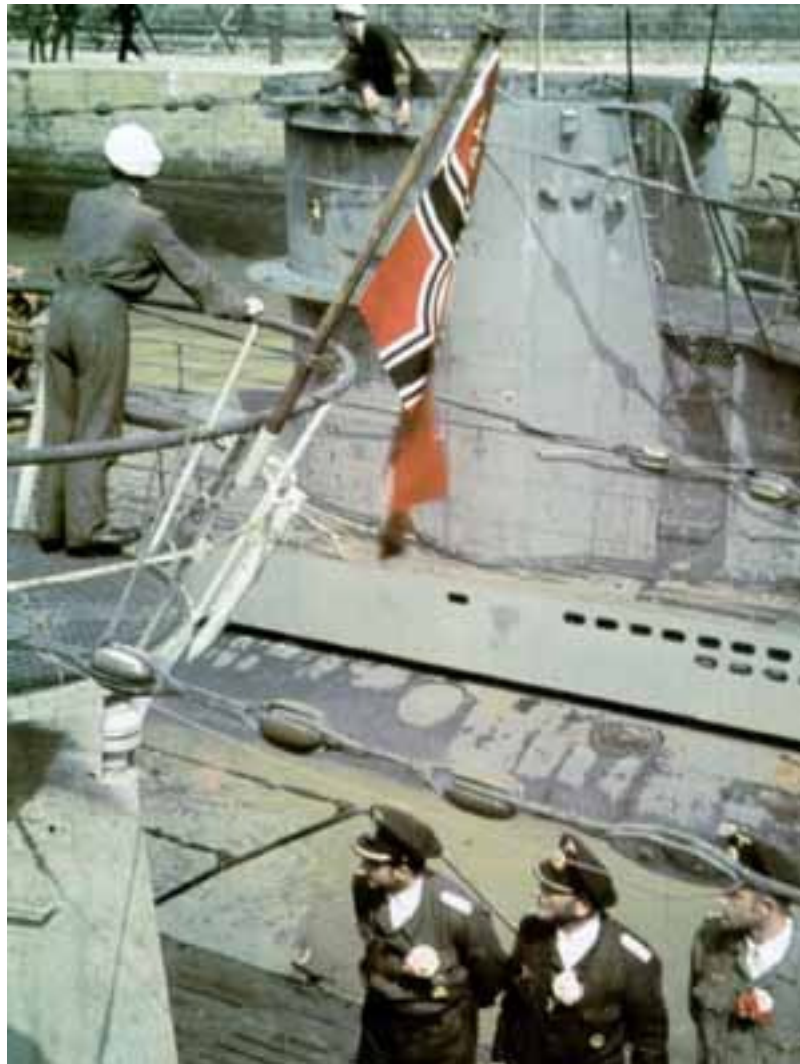
Above: U 405(left) and U 267(right) in St. Nazaire in April 1943. On the tower of U 267, the rectangular area behind the tower rungs is dark. The thin dark stripe between the tower and deck of U 267 is also evident. Other interesting features are the brown insulators on the aft jumping wires of U 405.

Vertical stripe behind rungs – A rectangular area surrounding the area behind the rungs on the tower sides was very often painted black or dark grey on training boats. This practice may have been in place because the toes of the sailors' dirty boots would smudge the grey paint when climbing up and down the rungs. On U 751 this area was silver in colour. This practice was less common on frontline boats, perhaps because the dark stripe would be visible against the lighter grey background of the tower.

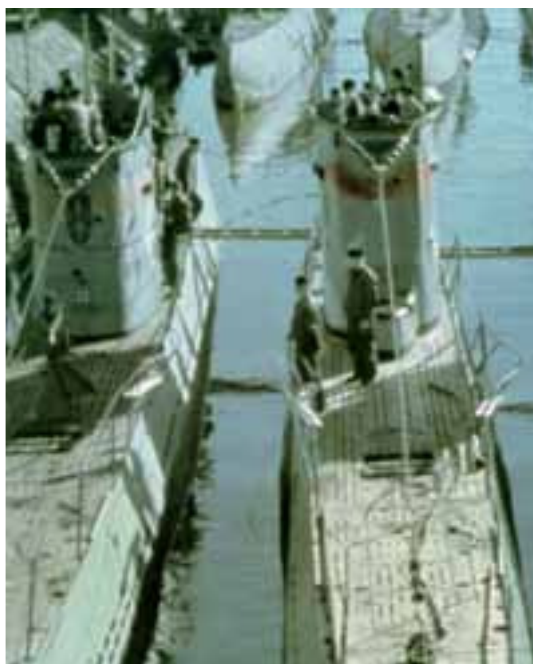
Above: School boats of the 21st U-Flottille in Pillau in 1943. The thin black stripe around the base of the conning towers of these *Dunkelgrau 51* Type IIs is evident. The stripe on the left boat – possibly U 61 - is thinner than on the right boat.

Conning tower base - A thin black or dark grey strip was painted around the base of U-boat conning towers.

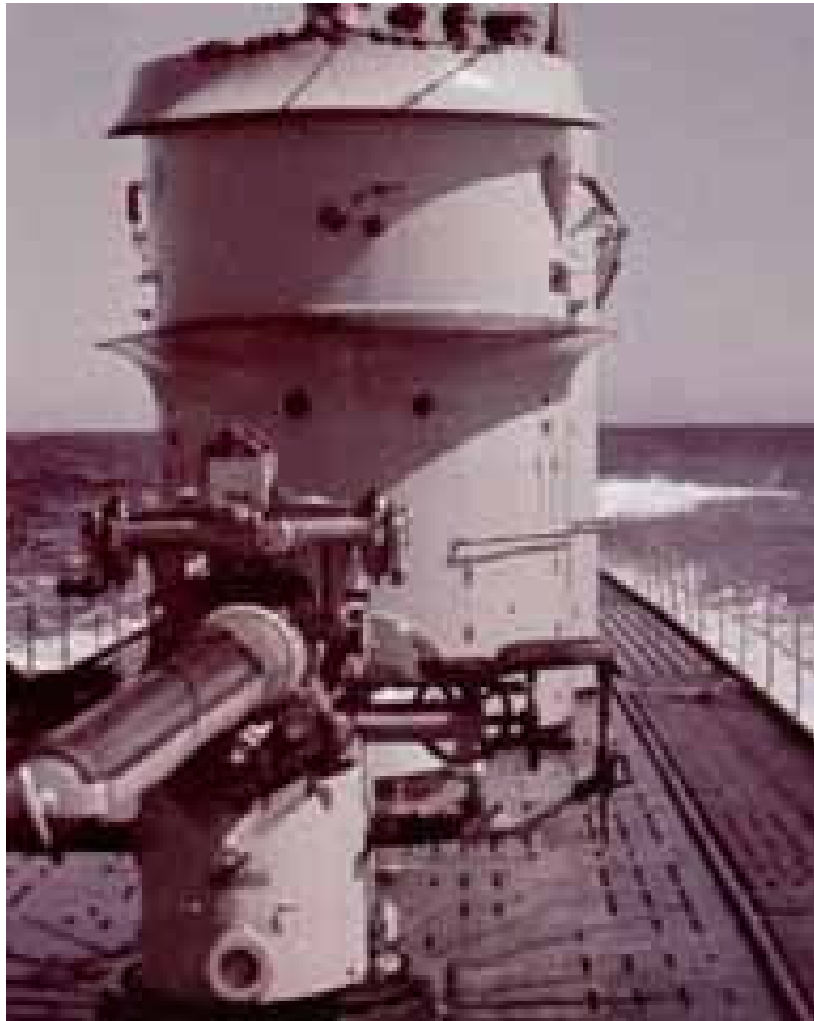
Above: A pristine U 164 in 1942. The upper half of the barrel, the upper half of the mounting upon which the removable elevation and traverse sights would sit, and the top half of the controls and gearing arms are all black. Just behind the gun, at the front of the conning tower, can be seen the fairing which housed the magnetic compass. The upper half of the fairing is also black. The light grey looks like *Hellgrau 50*.

88/105mm deck guns – The colours used upon the deck guns were not particularly consistent, and variations were common. The barrel, breech housing and main mounting body of the deck gun were often painted the same grey as the conning tower, but sometimes a darker grey colour was used. The base of the barrel (this was above the recoil tray), which slid back into a sleeve when the gun was fired, was heavily greased. The ring behind this, which acted as a guide for the barrel when it recoiled, was an unpainted metal which may have been bronze. The U-shaped padded gunlayer's harnesses were either artificial leather painted black or waxed canvas. The adjustable stems below were stainless steel. The circular control wheels were often painted black on the outside and grey on the inside. The handles for the control wheels were wooden, and presumably coated with black wood preservative. The ring above the base (below the main mounting body), upon which the compass headings were marked, was an unpainted metal, perhaps bronze. The upper half of the barrel was sometimes painted black or possibly dark grey for camouflage purposes (just as the horizontal surfaces of the conning tower were painted black). Even though the regulations called for "gradual transition" ie. feathered edges, the horizontal divide between the two colours had hard edges rather than feathered edges. Sometimes the top half of the mounting upon which the removable elevation and traverse sights sat, the top half of the controls and gearing arms, and the horizontal surface of the breech housing, were also painted black or dark grey.

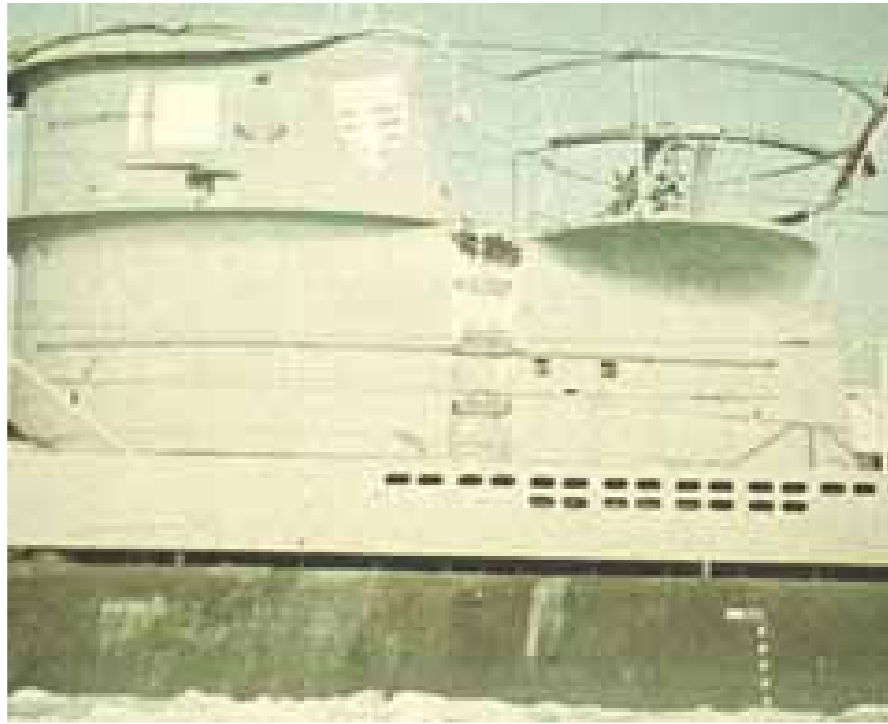
Above: A very cold U 751 in January 1941. The top of one of the six sets of white depth markings is visible at the right of the photo. The silver looking vertical stripe behind the tower rungs is possibly black paint shining in the brilliant sunlight. The white square and line at the top of the tower is a UAK tactical marking. To the rear is the boat's insignia (*bootswappen*), also known as emblem. It consists of an upright sword over blue waves and a golden sun. The sun is shining brightly upon the light grey *Hellgrau 50* tower and upper hull, and the dark grey antifouling *Schiffsbodenfarbe III Grau* on the saddle tank.

Type VIIs – Three sets of waterline depth numerals were marked upon both sides of the hull, making a total of six. These consisted of small white numerals that were aligned vertically. The first set was located a few feet aft of the bow, the second on the saddle tanks, and the third was a few feet forward of the stern. The first and second sets were of the same design. The top numeral, 0, started roughly at the division between the two greys, and the markings continued down the hull every 10cm to 1 (0,9,8,7,6,5,4,3,2,1). The third set, at the stern, differed in that the top numeral was 4. This top numeral was much closer to the top of the hull casing. The numerals ran down the hull until the bottom numeral, which was also 4, was reached (4,3,2,1,0,9,8,7,6,5,4). The 0 numeral was located roughly at the division between the two greys. On each of the six sets, a white rectangle was located just forward of the 0 marking.

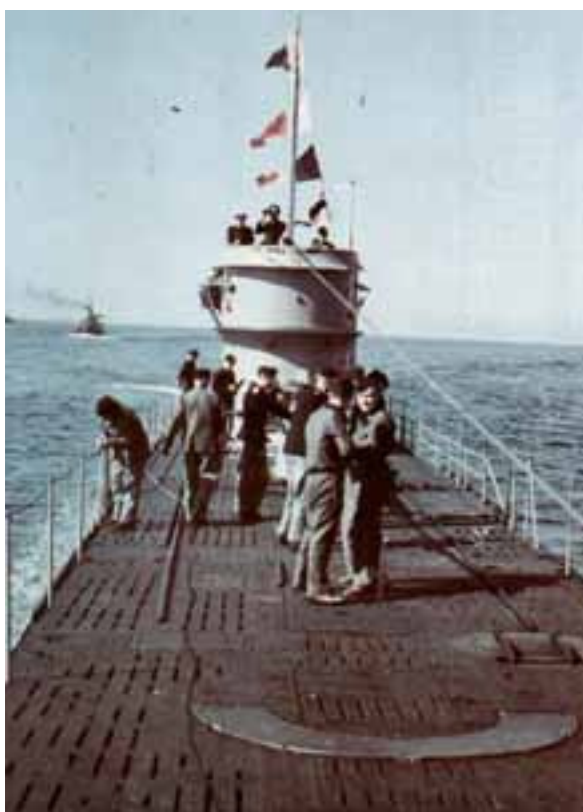
Above: The pristine looking Type IX U 128, with a *Hellgrau 50* tower, in May 1941. The freshly-stained wooden deck looks dark, with only a tinge of brown showing through. The metal hatch on the right of the photo, and the C-shaped metal part at the bottom of the photo, have been painted black.

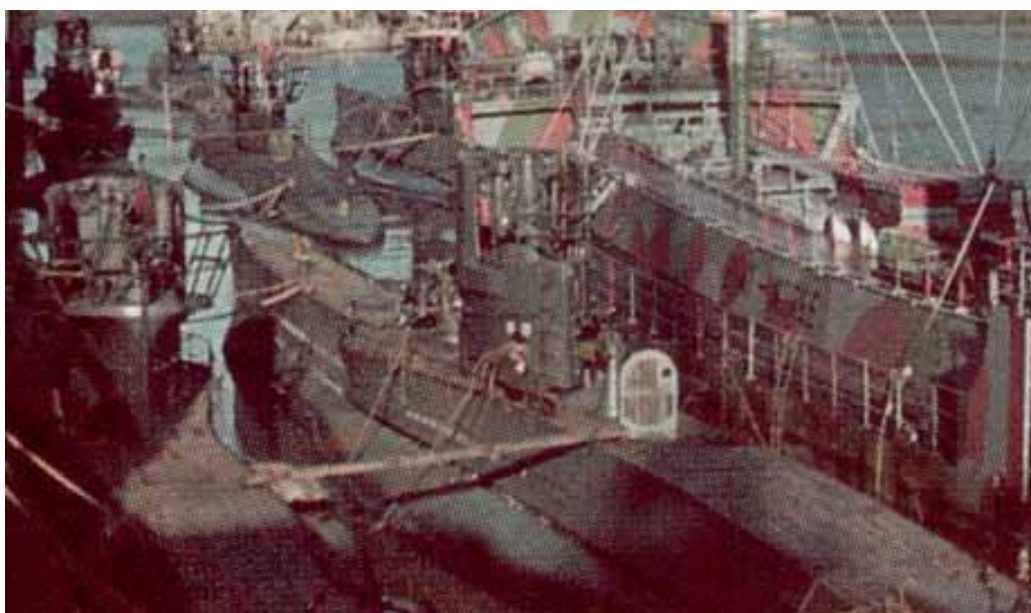
Above: The wooden deck colour can be seen on the U-boats in the foreground of this 1942 photo, taken in Drontheim in 1942. More brown is apparent on the stained decks than on the photo of U 128 above. Another interesting aspect is that all the U-boats are painted in the same dark grey paint.

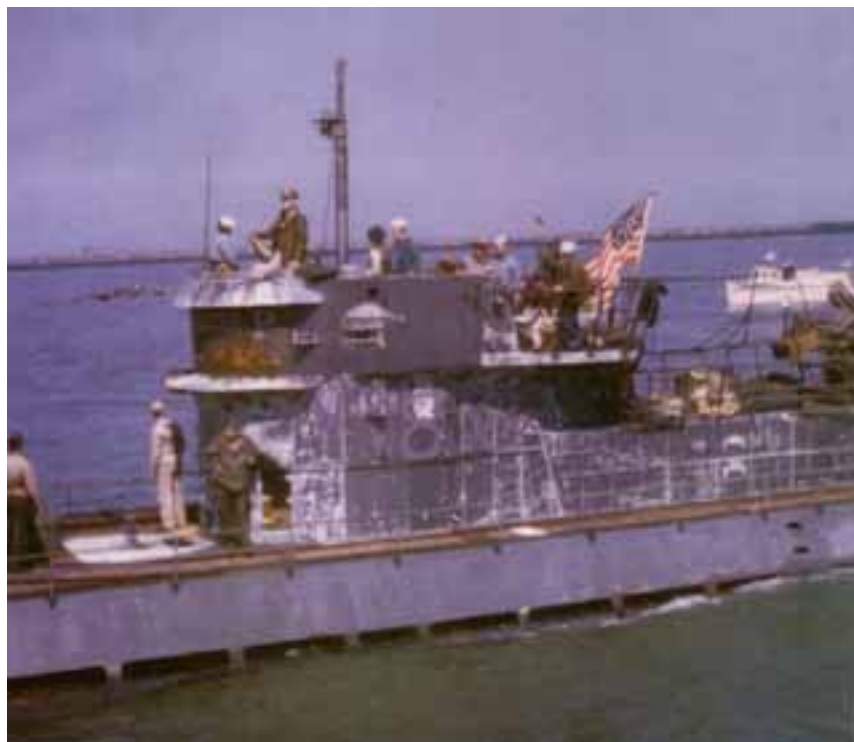
Above: The dark blue paint (*Blauschwarz 58/2?*) on U 805's tower has peeled away from the galvanised steel parts of the tower very badly. In contrast, the medium blue-grey paint (*Dunkelgrau 51?* or *Blaugrau 58/1?*) on the steel upper hull has fared much better. This photograph of the surrendered Type IXC/40 was taken on the 14th May 1945 near Portsmouth, Virginia.

Paint peeling - When U-boats were subjected to heavy weathering, their top layer of paint would peel off in patches. This would reveal either the older paint or the red lead preservative beneath. As discussed later, the Germans sometimes used grey as the colour of their anti-corrosion undercoats in preference to red. The first area for this peeling to occur in was often the bow and/or the waterline, where water would splash against the hull and peel away the top layer of paint. Bumps and scrapes when manoeuvring in harbour would also have resulted in paint chipping and flaking away. Later in the war, the poor quality paint and undercoat did not adhere well to the galvanised steel used on some sections of conning towers. When U 505 and U 805 arrived in American ports the paint on the galvanised steel parts of their towers had peeled very much more heavily than on other areas.

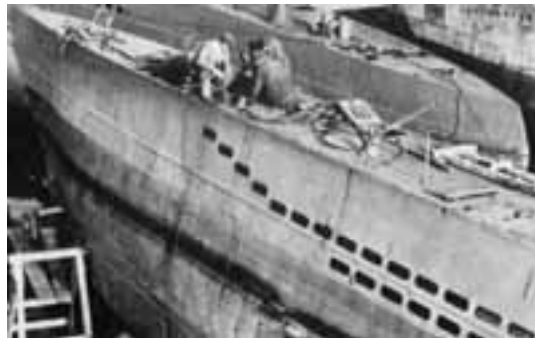
Above: The black horizontal line on this unidentified Type VIIC in dry-dock is a “grassweeds” line. It has built up on top of the dark grey anti-fouling paint, and is located well below the division between the two greys.

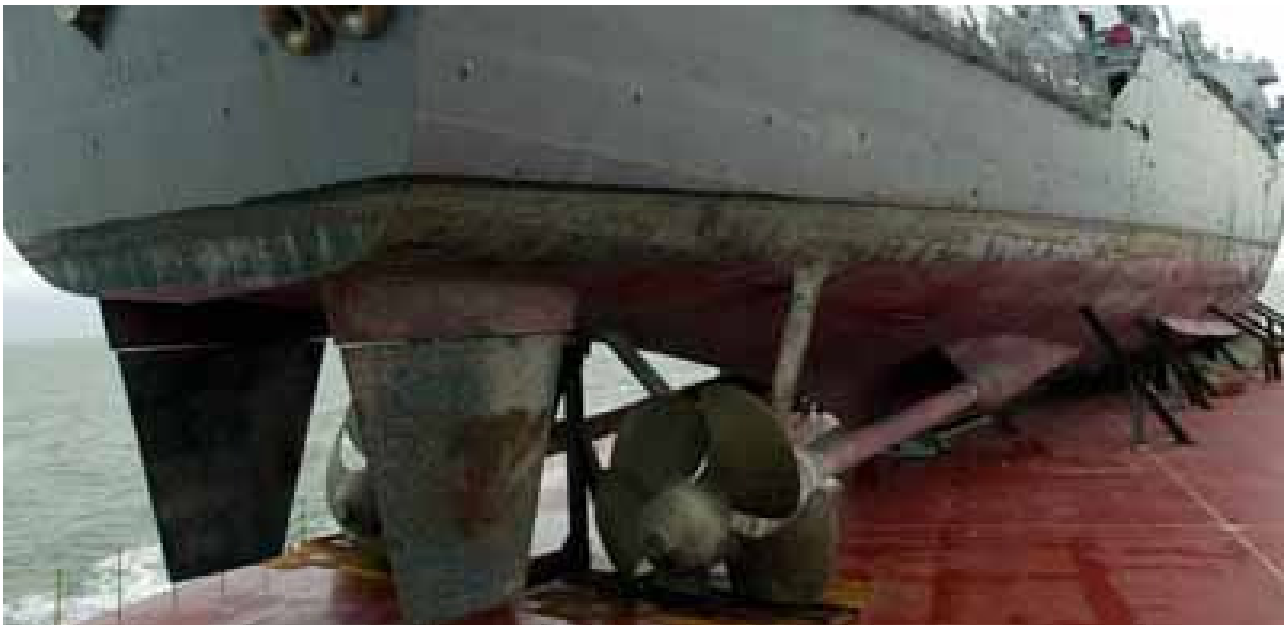
Above: A grassweeds line of assorted colours has built up over most of the black bootline on the *USS Cole*. Other plantlife is visible on the starboard rudder. When weathering their ship models, many modellers neglect the plantlife that builds up on the lower hulls of vessels.

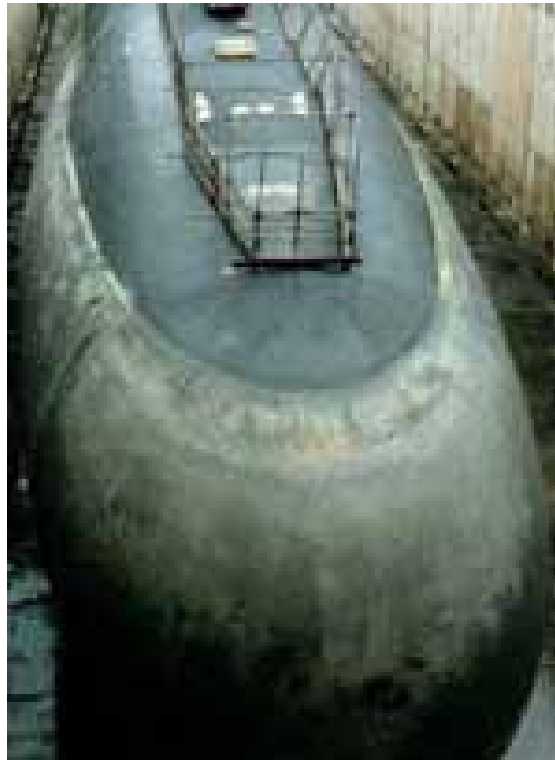
Above: The USS *Ohio* in dry-dock. The black submarine must have been lying in water for a long enough period that plantlife has adorned not just a foot or two under the waterline but for much of the lower hull. There is far less coverage farther down the hull. The area that would have been above the waterline is free from crud.
